The Locomotive

THE HARTFORD STEAM BOILER INSPECTION AND INSURANCE CO.

VOL. XXIX.

HARTFORD, CONN.
1912-1913.

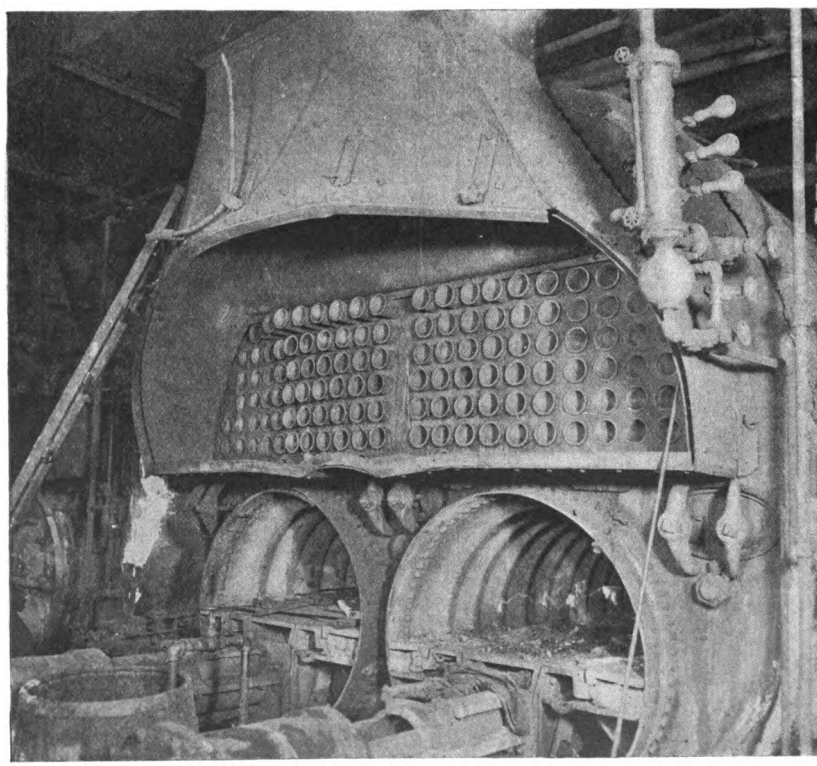
FIG. 1. DAMAGED FRONT OF BOILER.

From the data at hand the cause of this overheating cannot be definitely determined, but the boilers were reported clean, and if such was the case, forced driving or low water was probably responsible. Sheet "B" was thrown forward against the rear tube sheet "D" with such force that it drove a number of tubes through the front head, some of them extending as much as six inches from its face. This is shown on the accompanying view of the front of the boiler.

Three men were seriously scalded by this accident, one being so severely injured that he died shortly afterward. The property damage was chiefly confined to the boiler, with the exception of a brick wall located some distance in front, which was thrown down by the force of the explosion. The doors and hoppers of the boiler front were blown through a window twenty feet away.

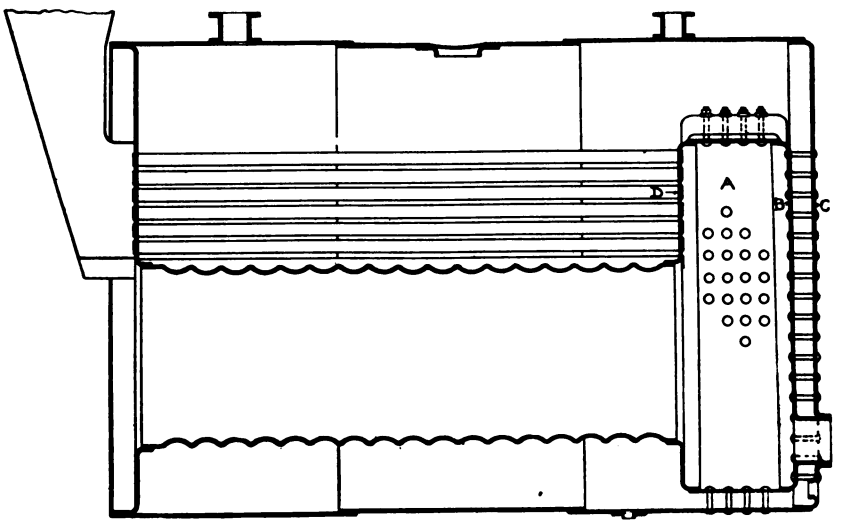
The vessel was what is known as a "wet back boiler." The general construction of such a vessel is shown by the line cut, Figure 2. The tubes and flues terminate in an internal tube sheet, "D," and communicate with a combustion chamber, "A," within the shell. The back of this chamber is formed by a sheet, "B," stayed to the rear head, "C." The space between sheet "B" and head "C" is filled with boiler water under pressure and gives the name "wet back" to the type. It was the bursting of this "wet back" and the consequent collapse of the combustion chamber that occasioned the disaster. Its initial cause was the pulling off of sheet "B" from the 172 staybolts which held it.

FIG. 2. SECTION OF BOILER.

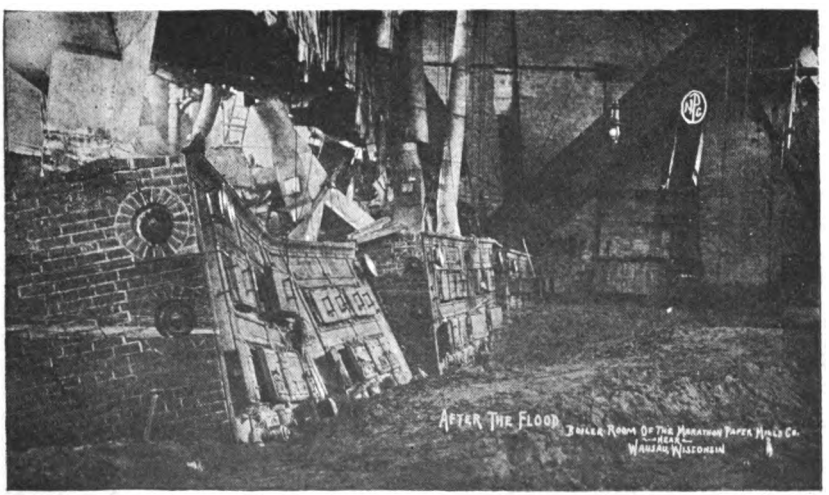
The accompanying illustration shows the condition in which the boiler plant of the Marathon Paper Company was left by a flood of the Wisconsin River, on which at Wausau, Wisconsin, that company's mill is located. Unusually heavy rains in the early part of last October had caused high water in all the streams of that neighborhood, and on the sixth of the month the Wisconsin had burst its banks and overflowed the Marathon Company's property, cutting new channels between its buildings, and as it developed, undermining the boiler foundations. Late in the afternoon of that day, before the water had reached the boiler room floor and while steam was still maintained, an initial settlement occurred in the end one of a battery of six boilers. This caused a break in a feed pipe by which three of the attendants were seriously scalded. Soon after, the water invaded the room and operations had to be suspended. At 8:30 in the evening the foundation completely collapsed at the rear, wrecking the

WRECKED BY A FLOOD.

These pages have frequently described the circumstances of a wrecked steam plant, the cause of which was attributed to low water, but it is quite a novelty to record in them a case such as this, where the opposite condition must be held responsible for the misfortune.

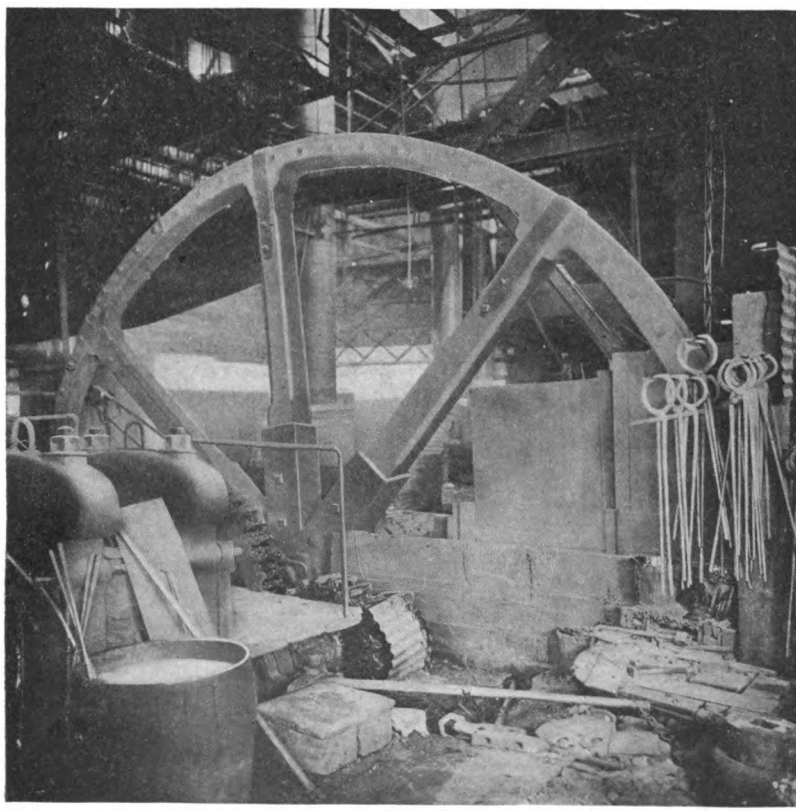
AN OLD FLY-WHEEL.

It would appear that in this case the governor pulley failed first, and we are told that fragments went through the roof with considerable violence. This failure may have been hastened by a blow delivered to the rim of the wheel by the governor weight. When relieved of the first wheel, the engine seems to have slewed around on its foundation, fouling the other pulley on the sub-base, and shearing its spokes free from both the hub and the rim. This rotation of the whole engine is in the right direction (left handed), to be explained by the principles of gyroscopic motion. If we consider the crank shaft balanced for weight by the two wheels, when running normally, it would become immediately unbalanced by the failure of one of them. This failure would probably occur at high speed, and so is favorable to such an assumption. It is of course well known to those who have experimented with the simple gyroscopic tops of their school days, that if the wheel is spinning, the top may

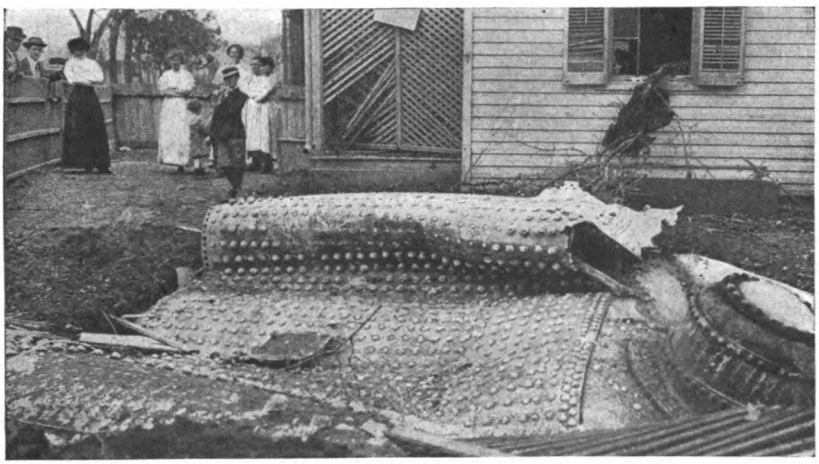
FIG. 2. WRAPPER SHEET AND DOME IN DOOR YARD.

failed by a gradual application of stress far in excess of that which they could safely carry.

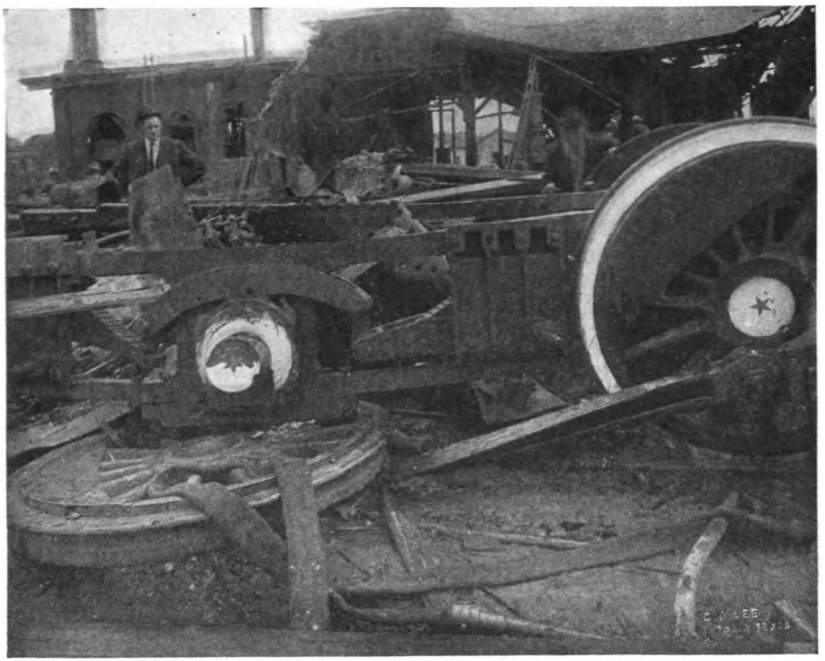
Reference to Figure 1 will show the general character of the explosion which resulted in the immediate death of 26 men and we are informed, in the subsequent death of three more, making a total of 29. It will be noted that the explosion apparently started in the firebox, which was blown directly down. The front head with many of the tubes attached will be seen to have been projected forward and to the right, while the wrapper sheet and part of the third course, carrying the dome, were blown backward some three blocks and were said by observers to have attained a considerable height, estimated to have been some 500 feet. These sheets, weighing some 6,000 lbs. landed in a dooryard and are shown in Figure 2. A glance at Figure 3 will show at once the terrific character of the explosion, and also the fact that the damage was much greater at the rear end of the locomotive than at the forward end, as one of the after drivers is seen to have been completely forced from the axle.

FIG. 3. DRIVER BLOWN FROM AXLE.

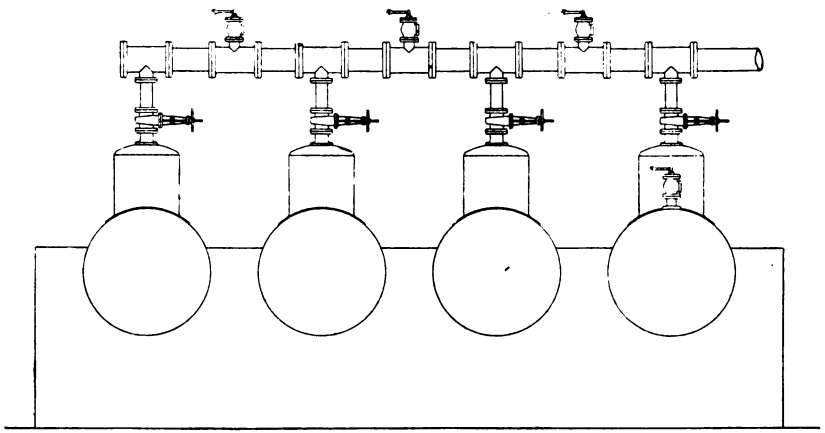
UNSAFE ARRANGEMENT OF STEAM PIPES.

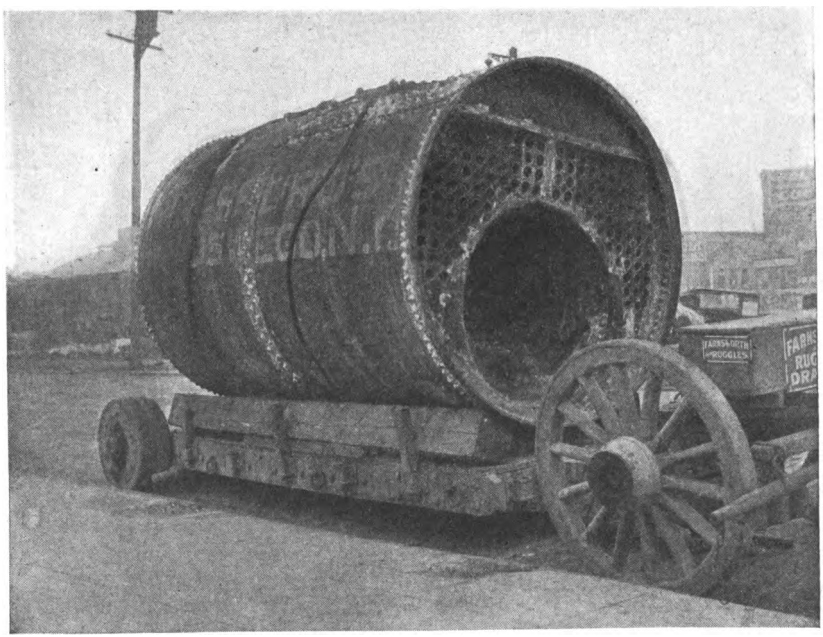
FIG. 1. BOILER OF THE "THOR."

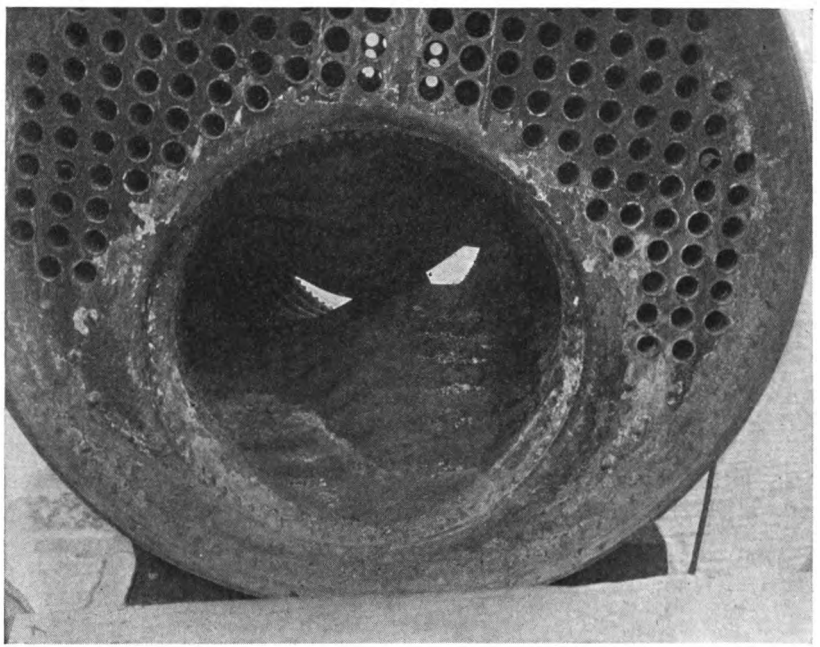
It would seem that this case is one of those preventable accidents which need not have occurred if the boiler had received regular and thorough internal inspections, as it is difficult to believe that a competent inspector could have failed to detect this particular trouble long before it reached the danger point. We understand that the boiler was comparatively new. No insurance was carried.

FIG. 2. THE COLLAPSED FURNACE.

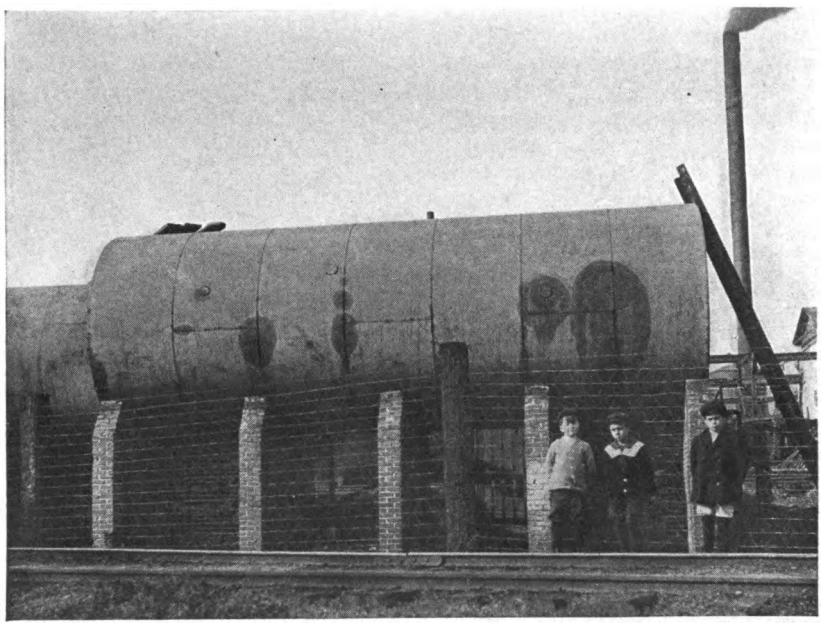
FIG. 2. THE PATCHED OIL TANK.

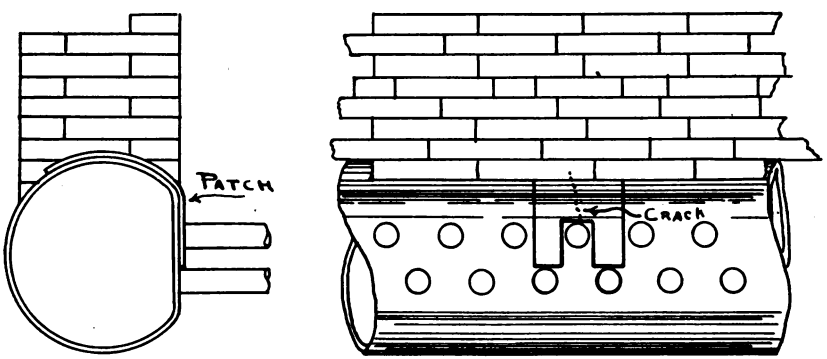
It is not known what pressure was attained after the repair was completed, as the attendant was kept so busy in a fruitless effort to maintain a fire in the furnace against the flow of water from the fracture, that he failed to note the reading of the pressure gage. Nevertheless the patch was not blown out of the furnace, and the greatest damage was to the purse of the mill owner.

FIG. 2. PATCH BRICKED AND CEMENTED IN PLACE.

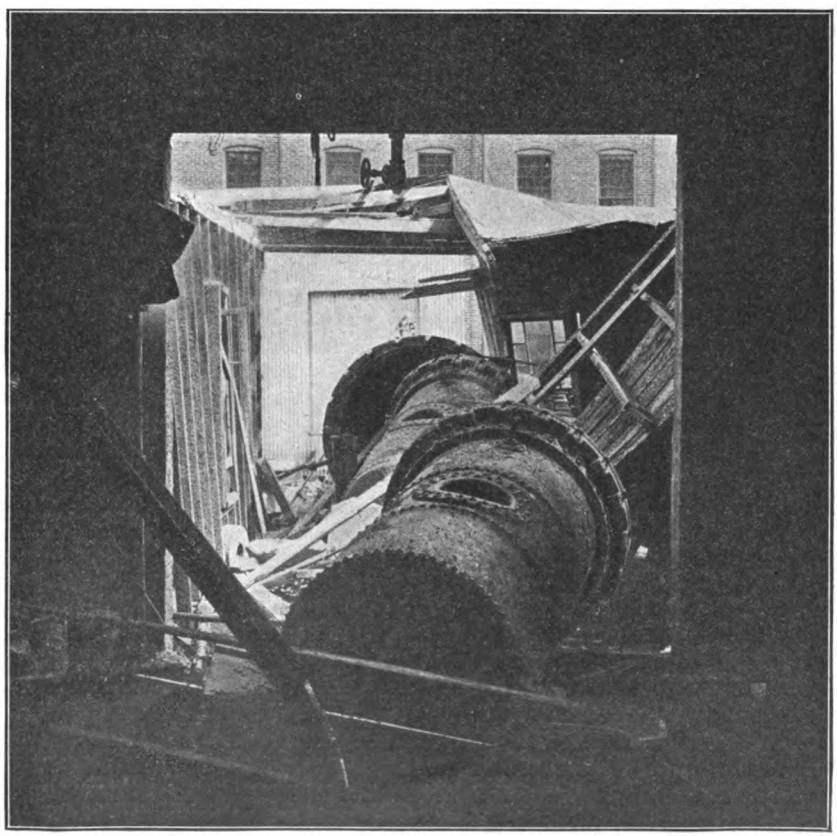
A VULCANIZER EXPLOSION.

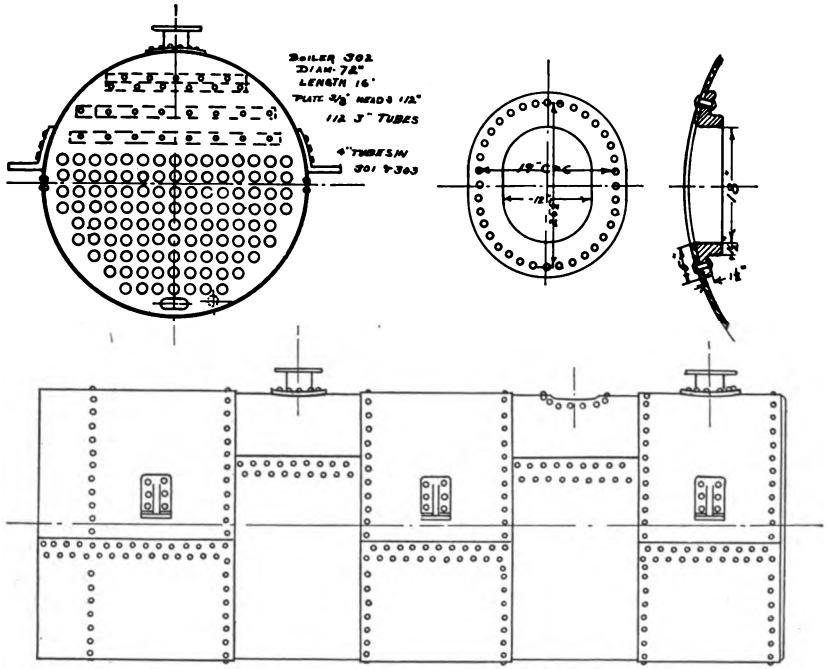
FIG. 1. DETAILS OF BOILERS 301, 302, AND 303.

The report of the HARTFORD'S inspector shows that these boilers, aside from age were in apparent good order. There was evidence that no rivets had been replaced, and that the seams had never been chipped and caulked. No fire cracks were visible, and although there was a slight indication of overheating on the bottom sheets of the rear courses, this was considered trivial. The only repairs known to have been made, were several complete renewals of the tubes.

These boilers had been designed for a pressure of 100 lbs., but owing to the low factor of safety which they would have at this pressure, due to the low efficiency of the longitudinal joints, they had been worked at a pressure of 80 lbs. At this pressure, the actual factor of safety, based on the pressure of 260 lbs. at which the manhole frame of boiler No. 301 failed was only 3.25.

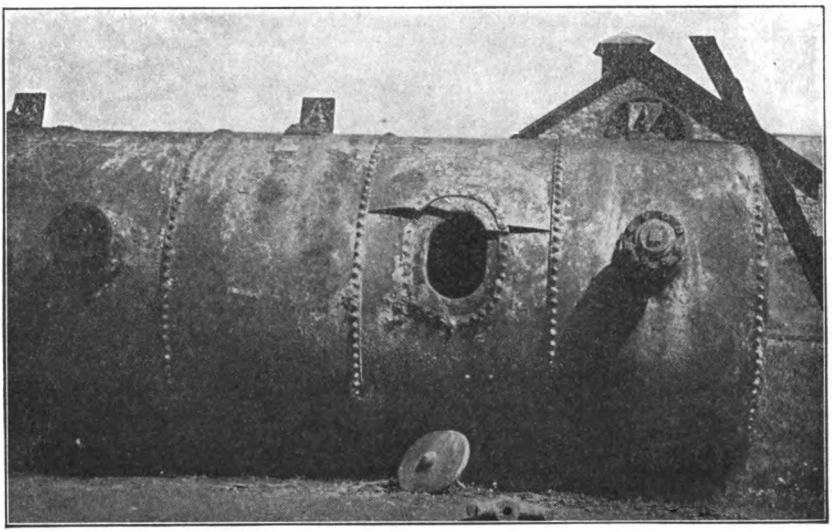
FIG. 2. SHOWING THE BROKEN MANHOLE FRAME OF BOILER 302.

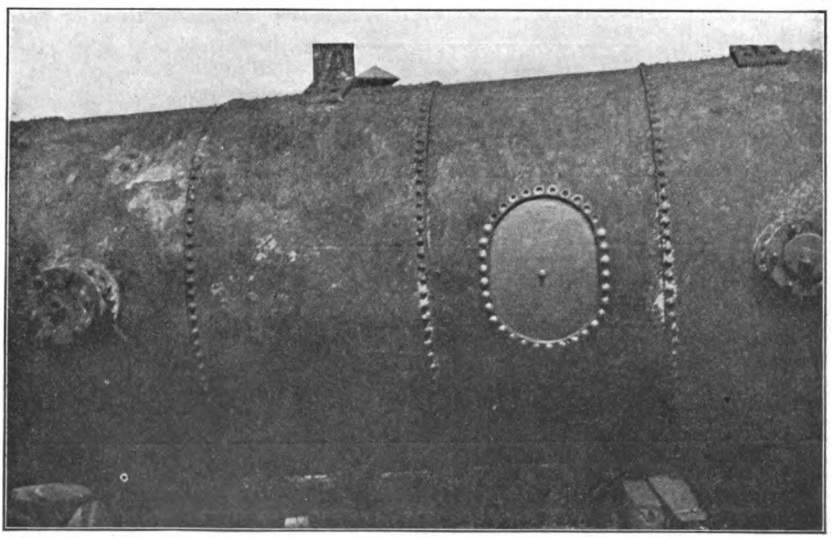
FIG. 3. APPEARANCE OF BOILER 303 AFTER TESTING.

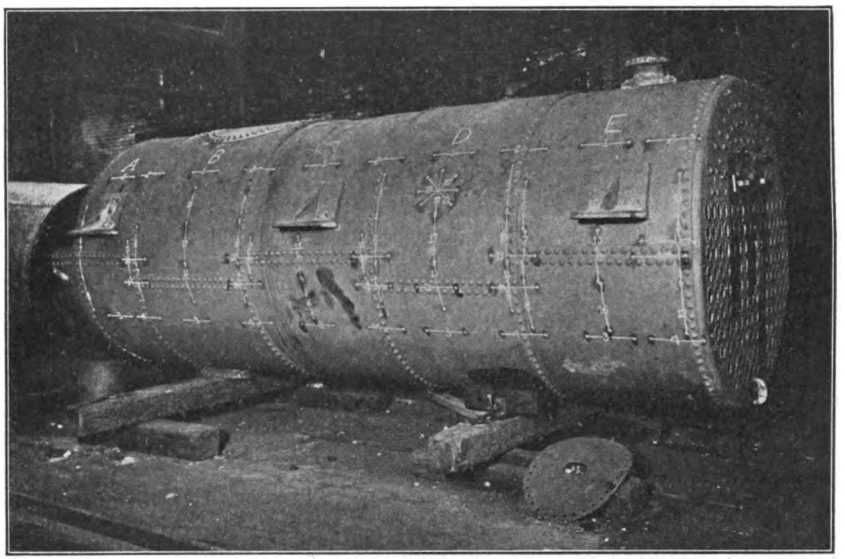
FIG. 4. BOILER 4092 PRIOR TO THE TEST. NOTE THE 10-INCH GAGED LENGTHS.

sheet. Their appearance prior to the test is shown by Fig. 4. The longitudinal joints were double riveted lap seams, ¾ inch rivets, pitched 2 inches, placed in punched holes. The plate thickness was ⅜ inch for the shell, and ½ inch in the heads. Both boilers contained 140 three inch tubes. Domes 2 feet 6 inches in diameter were provided on the second course, and cast iron manhole frames and safety valve nozzles were fitted to the middle and rear courses, respectively. Both boilers were made at the shops of the Whittier Machine Co., Boston, Mass., in 1881, of "Benzon" steel. They were known as No. 4084 and No. 4092 on the HARTFORD'S records, and were designated by these numbers in the report of the test published in the November 1911 number of the Journal of the American Society of Mechanical Engineers.

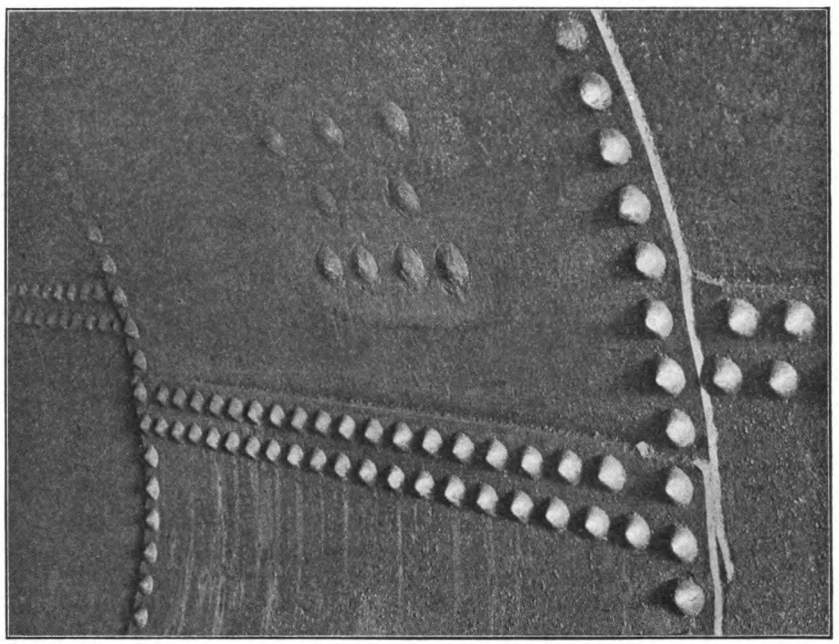
FIG. 5. SHOWING THE EVIDENCE OF DISTRESS UNDER THE LUGS AND AT THE LONGITUDINAL JOINT.

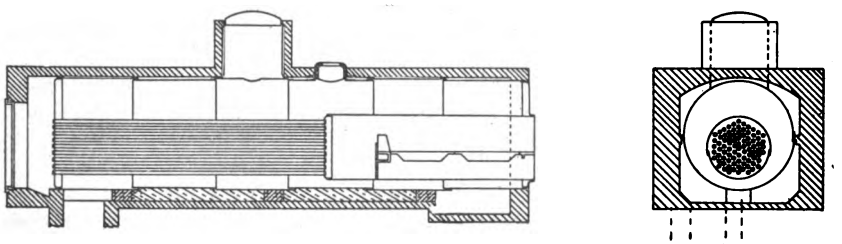
FIG. 6. BOILER KNOWN AS S-3.

Creusot, and were of the type illustrated in Fig. 6, cylindrical, with internal furnaces and direct tubes, surmounted by a dome. The settings were such that the products of combustion passed first through the tubes, then returned under the right-hand side of the shell to the front, where they passed across, and back to the flue, under the left-hand side of the shell. A longitudinal baffle wall for this purpose was provided under the center line of the boiler as is indicated in Fig. 6. The boilers were designed for a pressure of 71 lbs., but were later tested and worked at 78 lbs. (5.5 kg. per sq. cm.). They had a heating surface of 1270 sq. ft., were oil fired, and forced day and night except Sundays, for more than 30 years. In 1900 the rate of firing, which is typical of the service they rendered throughout their life, was such as to consume about 150 kg. of oil per sq. meter of grate per hour, which is equivalent to 31 lbs. of oil per sq. ft. of grate per hour, a very high rate indeed. The evaporation obtained was about 6 lbs. of water per lb. of fuel. The material of which the boilers were constructed was Creusot wrought iron, designated by the following numbers: body of the boiler, No. 2; heads, lower furnace sheets, and domes, No. 4; upper furnace sheets and front tube sheets, No. 6. The entire battery was overhauled between 1905 and 1907, as the result of a general breaking down from old age, and has since been entirely replaced. This overhauling however gave the opportunity for obtaining test specimens, and the data given was obtained at this time.

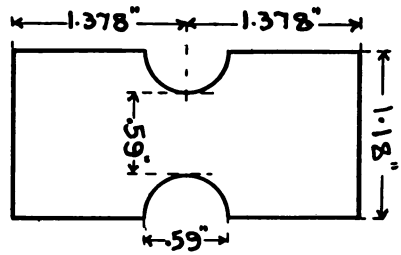
FIG. 7. IMPACT TEST SPECIMEN.

Subjected to the impact test, 3 out of 8 specimens failed under a blow from a ram of 44 lbs., falling 6.6 feet. Chemical analysis of the material showed its composition to be as follows:

These tests indicate that the No. 4 iron, which was lower in phosphorus than the No. 2, had not deteriorated to so great an extent, although its condition was far from satisfactory. It is rather interesting however, in view of the tests of steel boilers reported later, to see that the front head, which in this case was always at a moderate temperature, since the boiler was internally fired, should have deteriorated more than the rear head, exposed as it was to contact with the hot gases from the tubes.

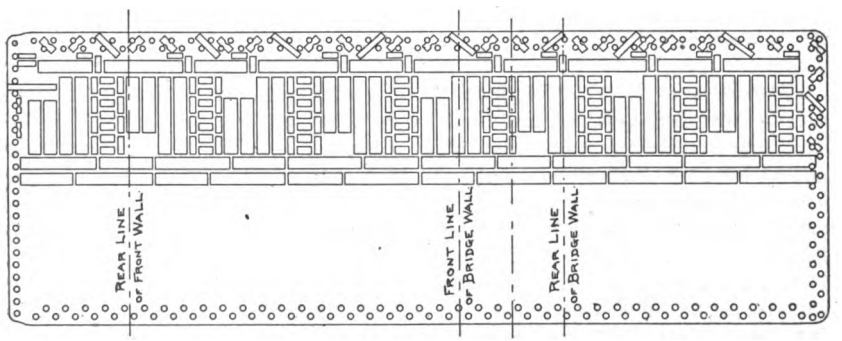
FIG. 8. FIRE SHEET OF C. SAY ET CIE. BOILER NO. 2. SHOWING THE LOCATION OF THE SPECIMENS WITH RESPECT TO THE FIRE.

TESTS OF STEEL FROM THE FIRE SHEET OF NO. 2 BOILER.

Untreated Specimens.	Reheated Specimens.	Reheated and Quenched Specimens.
SPECIMENS FROM PORTION OF SHEET PROTECTED BY FRONT WALL.			
Tensile strength	53,500	53,900	none tested
Elongation	25.2%	26.5%	none tested
SPECIMENS FROM ABOVE THE GRATES.			
Tensile strength	53,500	53,800	70,000
Elongation	23.0%	27.1%	20.6%
SPECIMENS FROM OVER BRIDGE WALL.			
Tensile strength	51,300	52,900	70,700
Elongation	24.7%	26.5%	19.7%
SPECIMENS FROM BEHIND BRIDGE WALL.			
Tensile strength	51,400	51,500	68,700
Elongation	24.8%	30.2%	21.2%

Cold bend test of 38 specimens, fairly satisfactory. The real extent of the change in this boiler steel was not disclosed until the impact tests were made. 162 impact specimens were tested all told, but as 10 of these were in the nature of special tests, to determine the effect of various sorts of abuse on

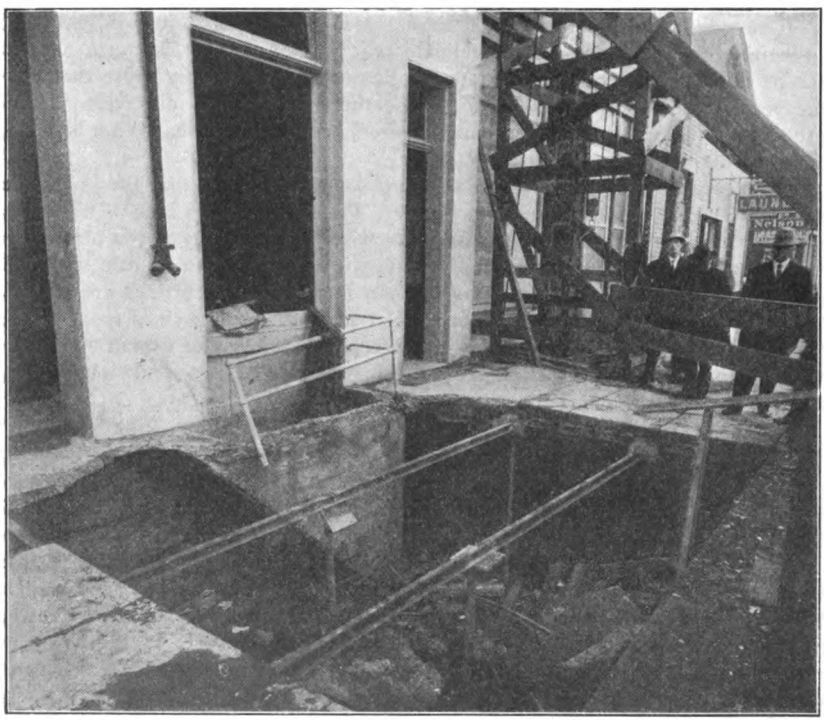
HEATING BOILER WRECK.

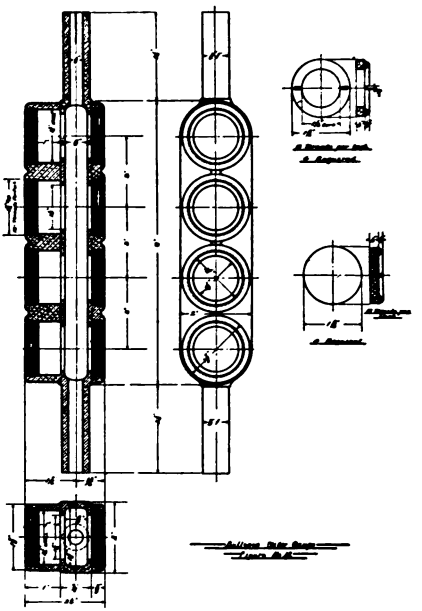
FIG. 12.— BULL'S-EYE WATER GAUGE.

A number of modifications of the bull's-eye construction have been proposed. When, as in locomotive practice, it is desirable that the water level be visible by both fireman and engineer, from opposite sides of the cab, two rows of bull's-eyes, staggered, and in a triangular shaped box, have been used. The prisms are prone to get dirty from the grease and scum that gathers in the water column and it is desirable that in the rear of the bull's-eyes should be located plugs to facilitate cleaning and removal of the bull's-eyes. Such a design is shown in Figure No. 12.

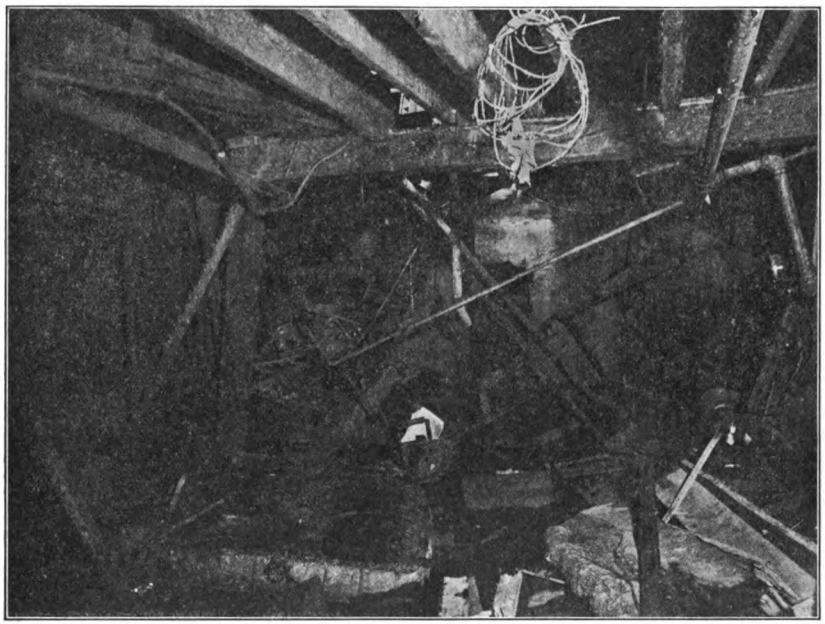
FIG. 1.— THE WRECKED BOILER ROOM, SALEM BANK AND TRUST COMPANY, SALEM, ORE.

Briefly the story is somewhat as follows. The building of the Trust Company was being remodeled, and at the time of the explosion, was unoccupied with the exception of the first floor, which contained the offices of the bank, and of Mr. Roberts, an insurance agent. The boiler, which had been purchased at second hand, was installed during the summer and stood directly under the office of Mr. Roberts. (This is the room the windows of which are shown on our front cover.) As only the first floor required steam, and

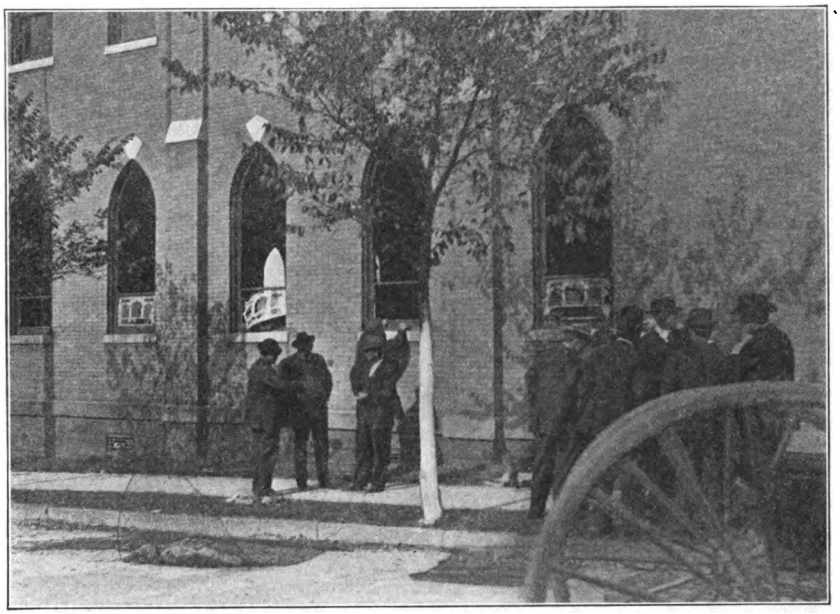
FIG. 2.— EXTERIOR OF CHURCH, SHOWING WRECKED MEMORIAL WINDOWS.

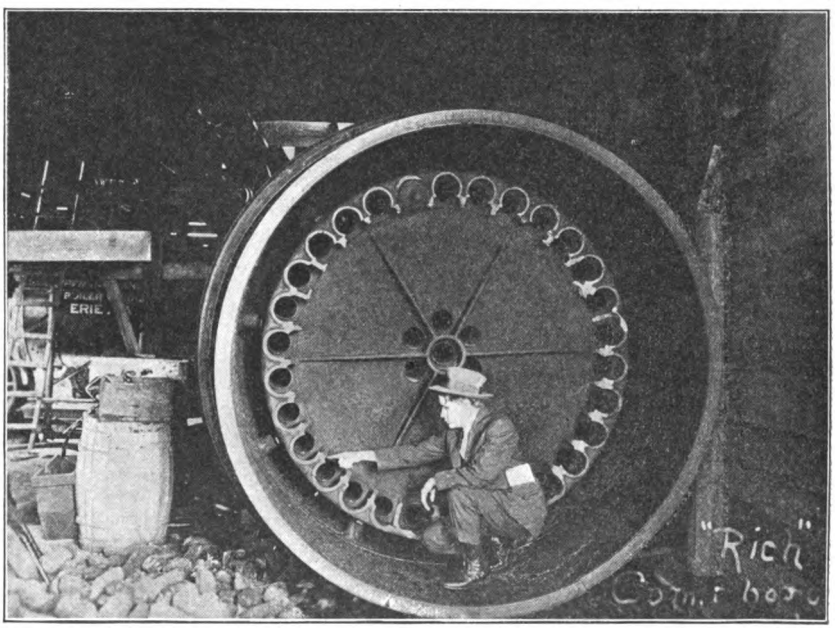
FIG. 3.—THE INSIDE OF THE EXPLODED DRYER HEAD.
THE MAN IS POINTING TO ONE OF THE OLD BREAKS.

safety valve or proper drain connection. This would indicate several possible reasons for its failure. The fact that it was inadequately drained would have permitted it to fill with water up to the level of the central axis when idle, and when steam was turned on a violent water hammer might have been produced Then it could easily have been subjected to a severe and unknown over pressure, due to the absence of the ordinary safety devices. The very violence of the explosion, which killed three men and seriously injured a fourth, and which carried the heavy head seen in Fig. 2 a distance of 350 feet — the head was said to have weighed some 1200 lbs. — would indicate that the vessel must have contained considerable water which added its heat energy to that in the steam, when the explosion occurred. A number of old and deep cracks were found in the reinforcing webs which surrounded the tube ends in the outside row. The man seen in Fig. 1, is pointing to one of them.

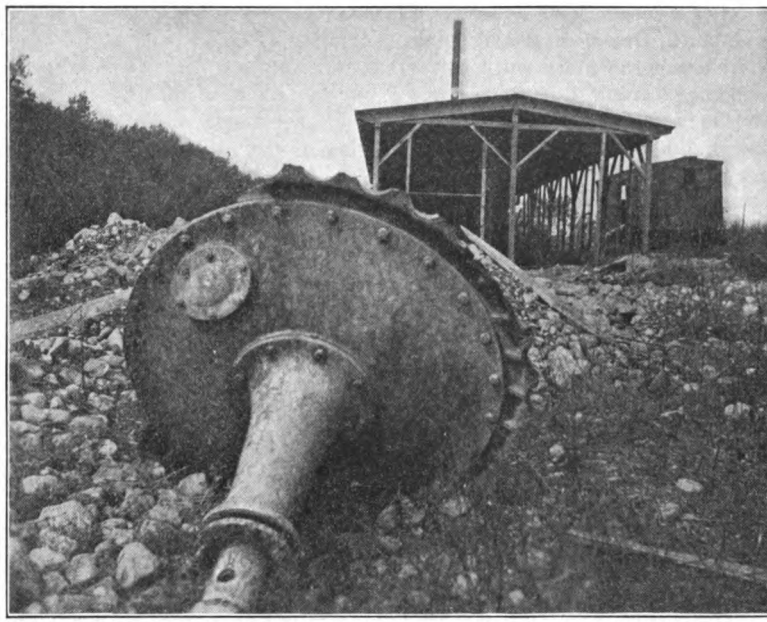
FIG. 2.—OUTSIDE VIEW OF OUTER HEAD.

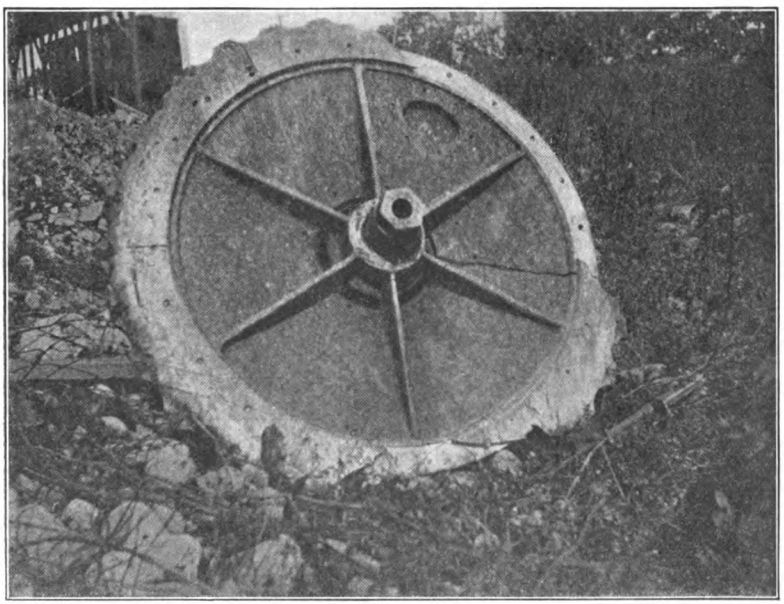
FIG. 3.— REVERSE SIDE OF OUTER HEAD.

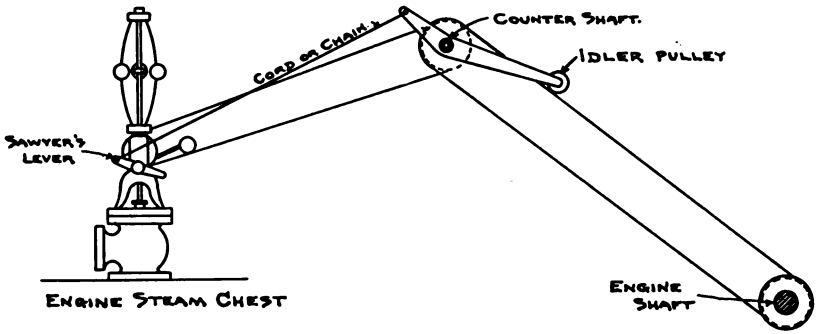
FIG. 1.— SAFETY DEVICE FOR A COUNTERSHAFT DRIVEN GOVERNOR.

When it is necessary to use two belts, as noted above, it is evident that the automatic safety stop on the governor will not operate if the belt that runs from the engine shaft to the counter-shaft should break. In this case, the governor would stop revolving and drop to its lowest position, allowing full steam admission to the cylinder, which would result in the engine racing. To obviate this danger, a second idler pulley similar to the one attached to the governor should be provided to operate on the belt leading from the engine to the counter-shaft, as shown in the accompanying sketch. This can be fitted with very little trouble or expense by the engineer or other mechanic about the plant, as the outfit only consists of the pulley and arm with cord or chain to attach to the Sawyer's lever on the governor, which also operates the safety stop. When thus connected, the governor can then be relied upon to stop the engine if either of the belts break.

When conditions compel the use of a counter-shaft with an additional belt to drive a throttle valve governor, it is very important that precautions should be taken to insure free action of the automatic safety stop. So that it will stop the engine if either of the two belts should break. So many cases have come under our observation where no provision has been made for such an emergency, that it may be well to call attention to the proper way to connect up governors operated in this manner. Of course, it will be understood that reference is now made to the throttling governor with an automatic safety stop attachment. This safety stop is designed to be operated by an idler pulley, which rides on the governor belt, and is so arranged that should the belt break, the idler will drop to a lower position, thus tripping the safety latch, and allowing the throttle valve to close.

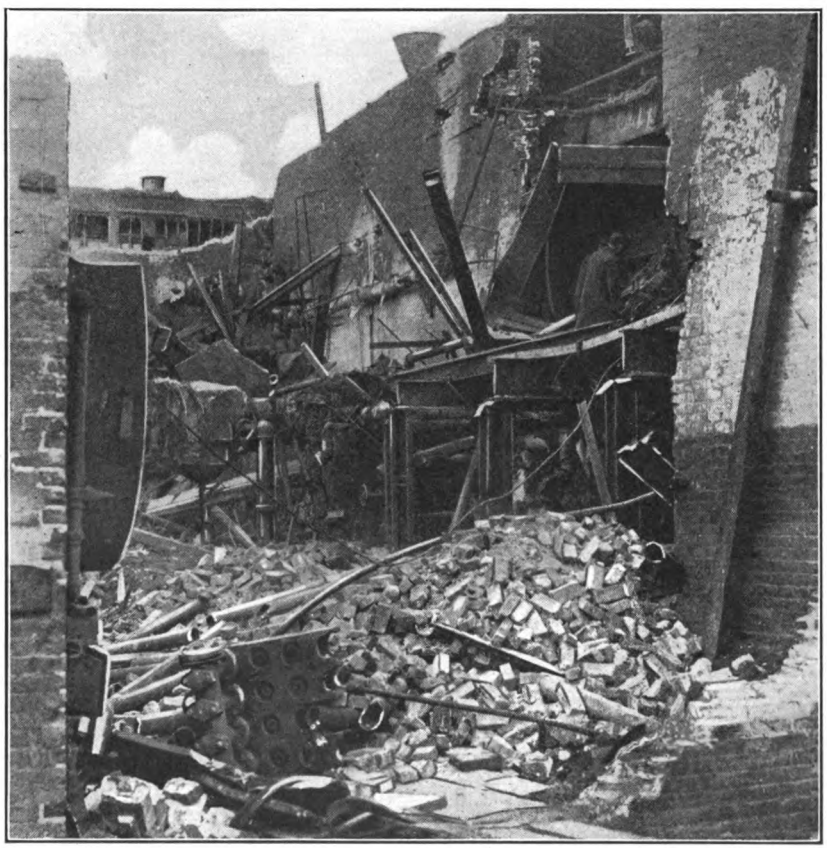
FIG. 5. A NEAR VIEW OF THE WRECK. ECONOMIZER EXPLOSION AT SAYLESVILLE, R. I.

A fuel economizer exploded Tuesday, January 14, 1913, at the Glenlyon Dye Works, Saylesville, R. I. The accident occurred at about 3.50 o'clock in the afternoon. Beside destroying property to the extent of about $26,000.00, two men lost their lives, and some seven or eight others were injured more or less seriously.

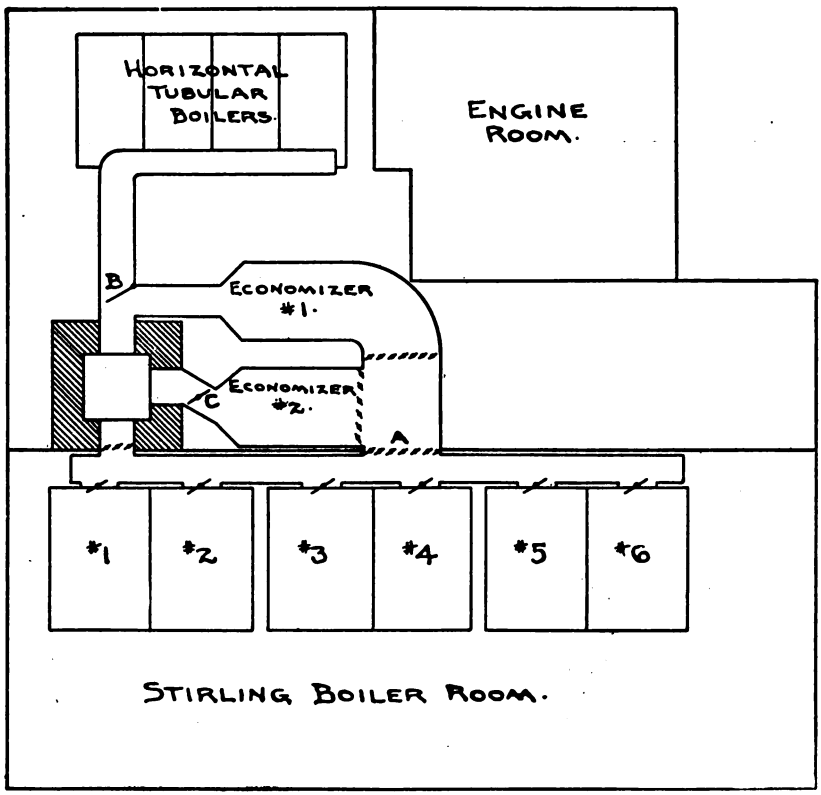
FIG. 1. PLAN SHOWING ARRANGEMENT OF BOILERS AND ECONOMIZERS.

The arrangement of the boiler house and its equipment, as it existed before the accident, is shown in our sketch plan, Fig. 1. There were two boiler rooms, one containing six 325 horse-power Stirling boilers, and the other containing the stack, the economizers, and a battery of four horizontal tubular boilers, together with the feed heaters, pumps, fans, fan engines, and other boiler room auxiliaries. As will be seen, only the gases from the Stirling boilers could pass through the economizers, while those from the tubular boilers went direct to the stack. The economizers, two in number, were behind the stack, and side by side, parallel to the division wall. They rested on a platform about 10 feet above the floor. This platform consisted of longitudinal I beams, between which were turned brick arches, and these in turn rested on transverse I beams,

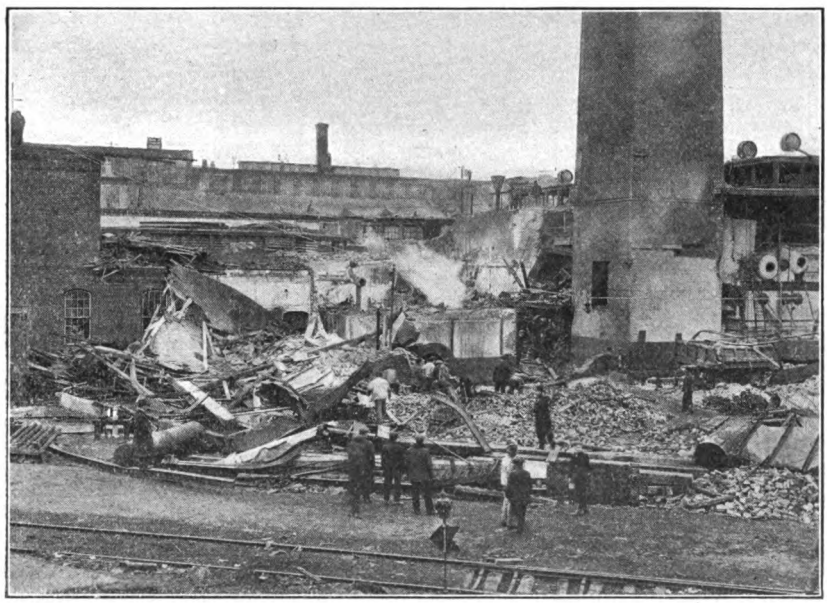
FIG. 2. GENERAL VIEW OF THE WRECKAGE.

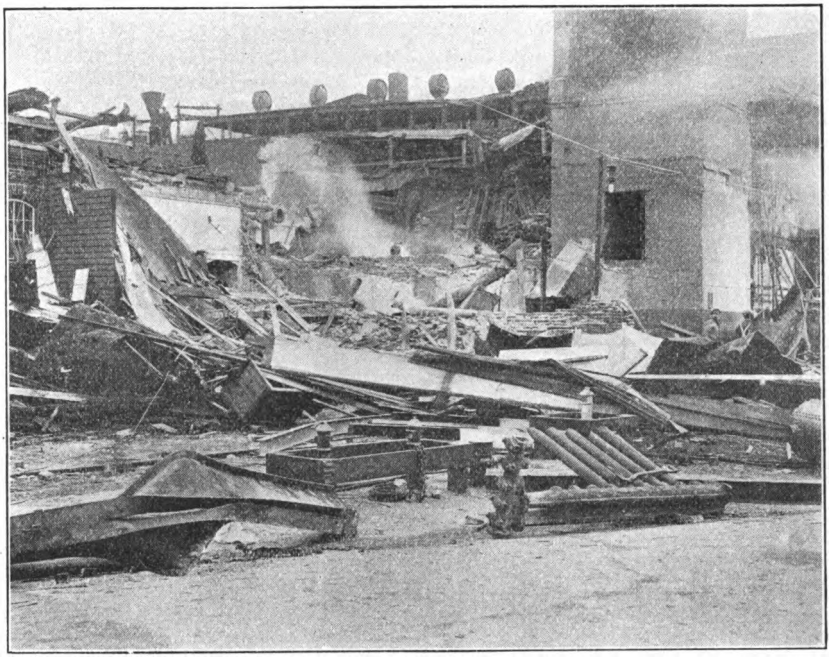
FIG 4. SHOWING PORTIONS OF THE NO. 2 ECONOMIZER STANDING ON ITS PLATFORM JUST BACK OF THE STACK.

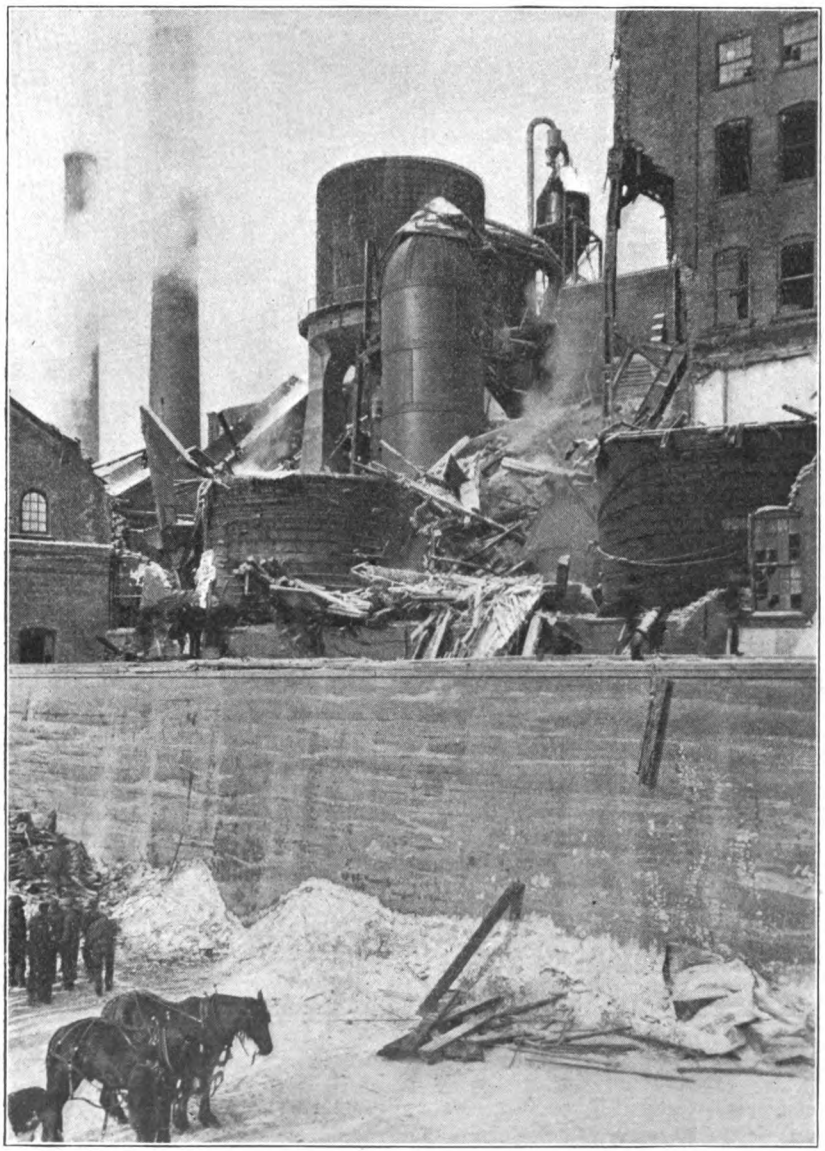
Fig. 1. General View of the Destruction at Grand Mere.

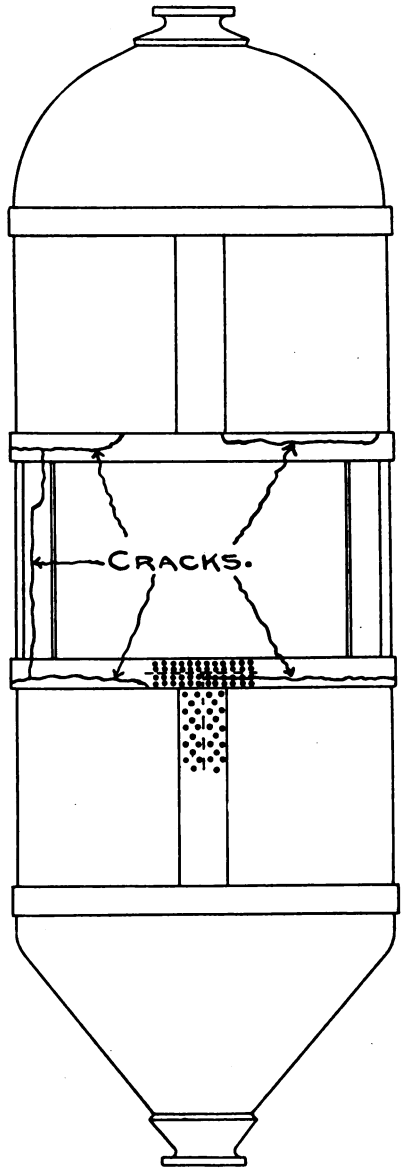
FIG. 3. ELEVATION OF DIGESTER SHOWING LOCATION OF THE LINES OF FAILURE.

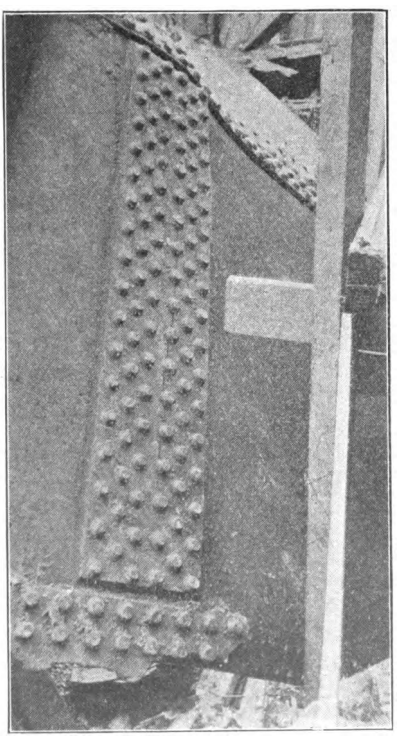
FIG. 5. CRACKED BUTT-STRAP.

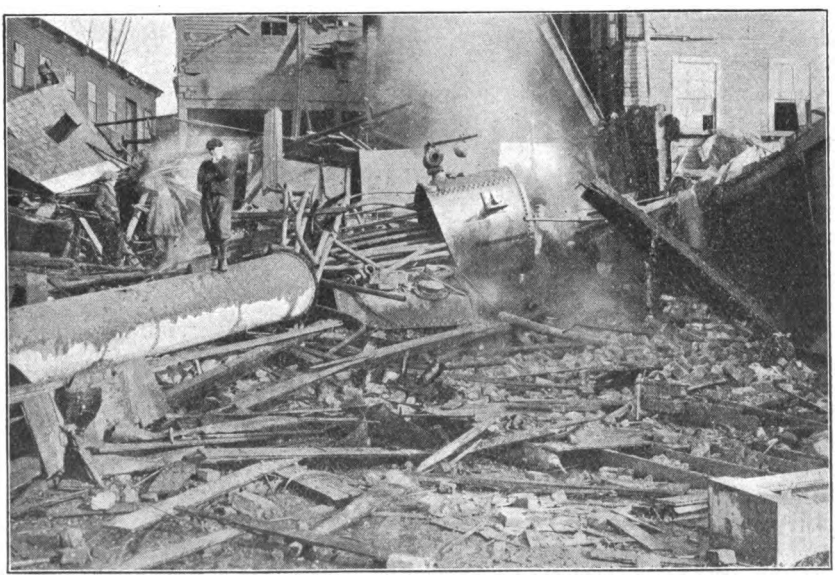
FIG. 1. BOILER EXPLOSION AT KEENE, N. H.
